Three Ways to Cut Radiological Cleanup Costs, Conducted at Former NAS Alameda, California

Presented By
Matthew Slack
NAVSEA

Describe three ways to cut radiological cleanup costs implemented at Alameda's Operable Unit [OU] 2C, including for:

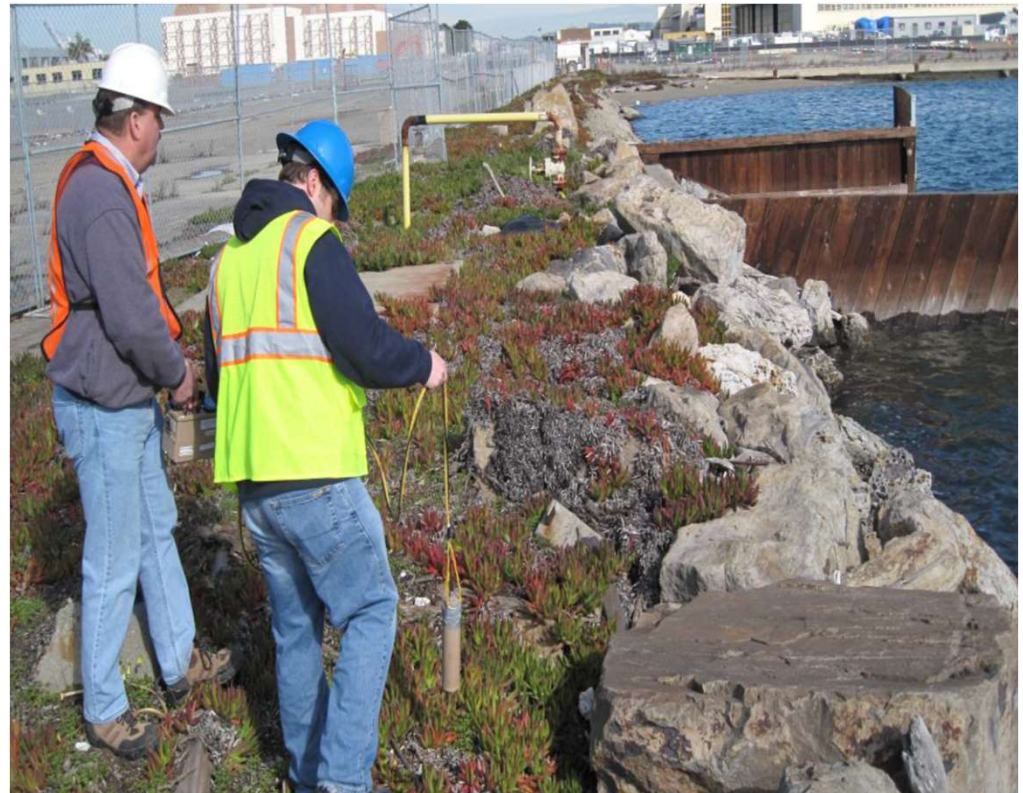
**Discovery of radium paint waste
Riprap at Seaplane Lagoon**

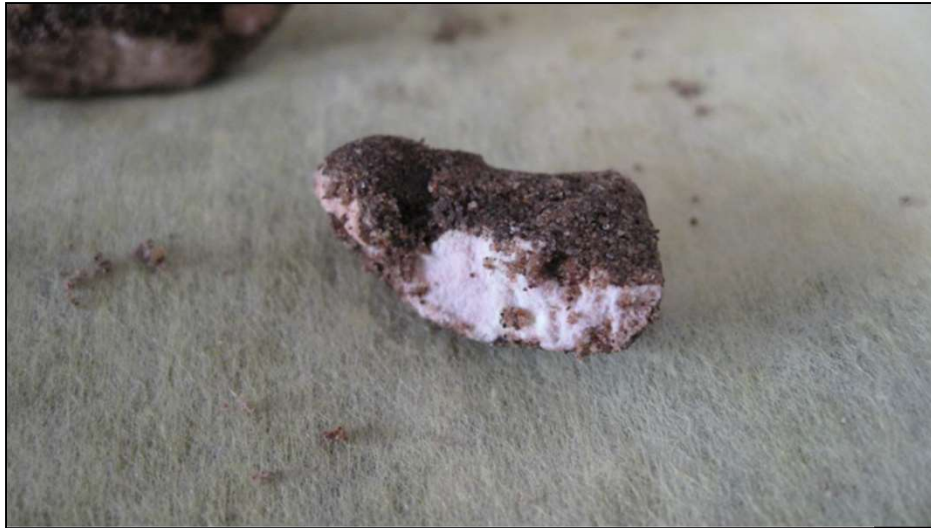
Fragment of radium paint

Dose rate reading: 70,000 μ rem/hr on contact

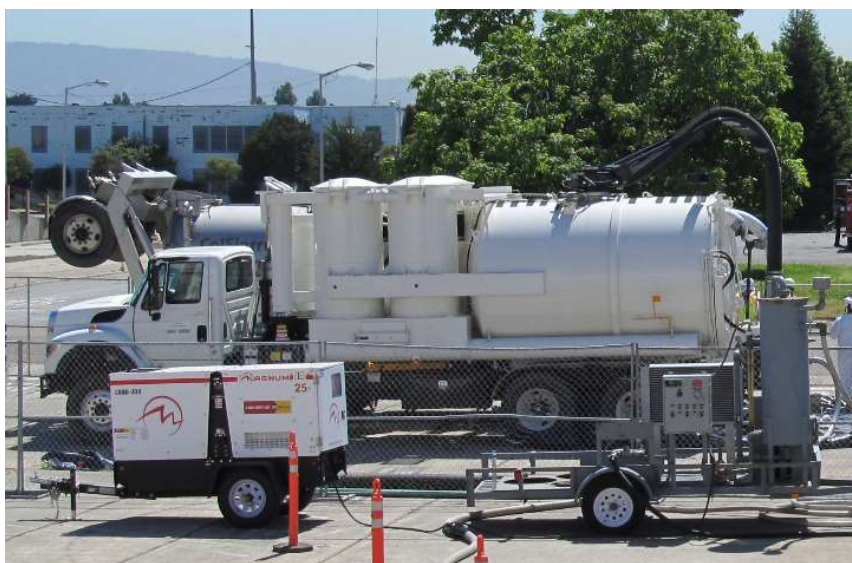
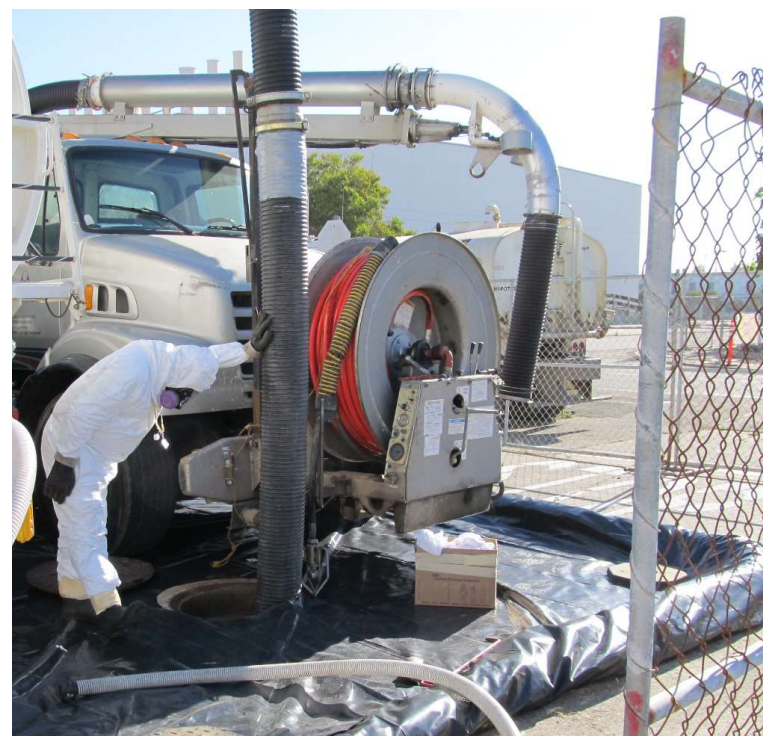
Hydrojetting Drain Lines

- Conducted Hydrojetting of storm drain Lines A, B, and G (estimated 13,628 feet of line) followed by video camera with detector (and sampling outside lines if known impacted lines); no further action documented in December 2016 Record of Decision
- More contaminated line (Line F) that contained in excess of 1,000 pCi/g of Ra-226 in sediment was removed and replaced.
- Industrial waste line remedy is institutional controls (ICs), with minimal removal of sections to more easily allow redevelopment infrastructure to cross the line.

- Hydrojetting approach vs. removal and replacement of 13,628 linear feet of storm drain lines A, B, and G:
~\$38M
- Using SCM vs. standard building survey equipment:
~\$13M

- The Hydrojetting (with verification) approach results in significant savings compared to removal and replacement of drain lines.
- Use of the SCM results in significant cost savings and regulatory agencies in California like use of the SCM vs. other methods for surveying buildings.
- Integrating radiological investigation and cleanup work with non-radiological/CERCLA work can result in more cost-effective remedies at the site.

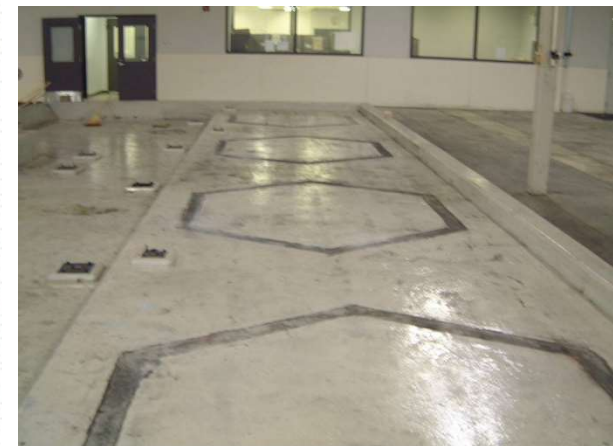
SCM Graphics

SCM Color Graphic Images of Radiological Contamination:
Left: Building 5 Ra-226 paint room contamination;
Right: Another project showing contamination beneath
pads (SCM image and photo)

Building 5 is an approximately 1 million square foot building with no power. Work Plan specified 12 mrem/yr Federal dose standard. The surface contamination monitor (SCM; gas proportional detector for alpha and beta particles) was able to efficiently survey the first floor and identify contamination quickly:

- a 180 cm detector will cover an area 6 times faster than a 30 cm detector (all other parameters being equal)
- added benefits come from the equipment's sensitivity and ability to process data and provide color graphic images
- State of California regulators praised SCM use and immediate identification of contamination.

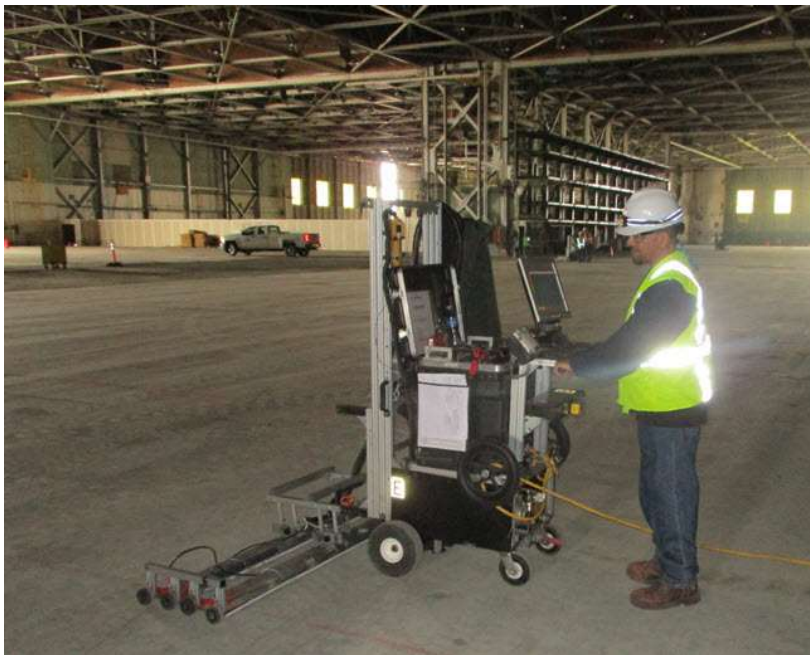
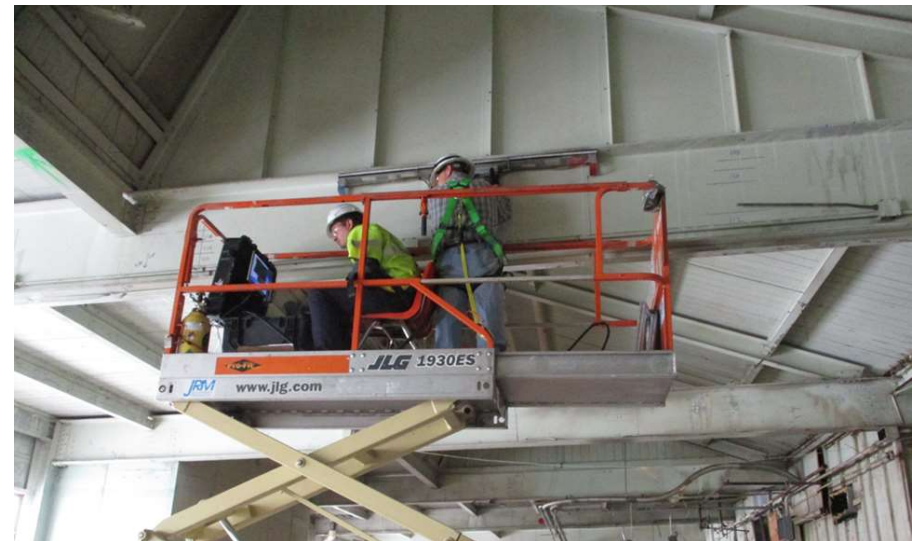
SCM Surveying Hangar Floor (left); SCM ~30 feet from floor, surveying I-beams and ceiling (right)

The Building 5 radiological remediation included use of a recently developed SCM model with:

- electronics package replaced with small computer chips
- computers with faster, more powerful systems (e.g. SurfacePro)
- battery power instead of AC and
- a weight less than one-third the weight of the older model SCM.

This results in significantly greater ease of use in the field; it was very efficient in this 2-story building with no electricity.
